Midnite E-Panel/Apollo T80 Shunt Board Issues
Compiled by: John Raynes, RE Solar, Torrey, UT
Date: June 14, 2007

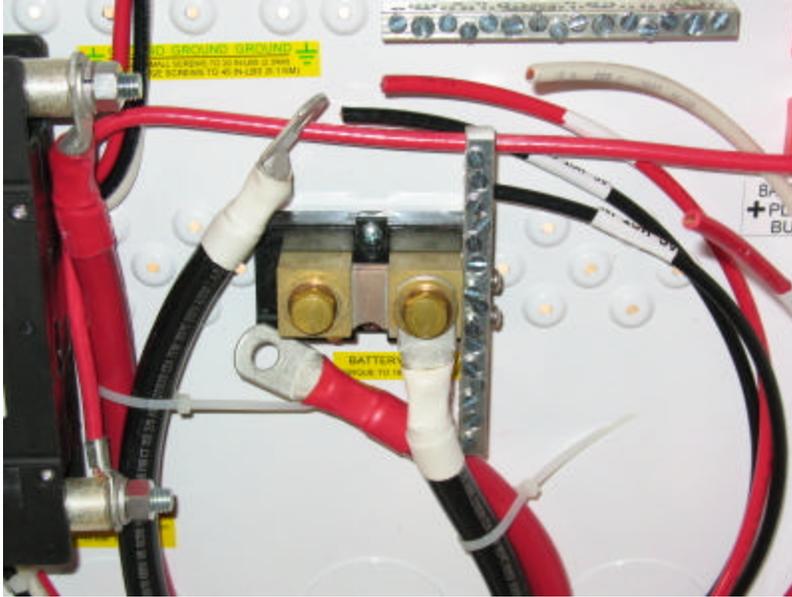
The E-Panel's shunt and neutral bar assembly as configured doesn't allow for the required clearance of the Apollo shunt board.

The neutral bar needs to be shifted up (as seen in the above picture) in order to leave room for the shunt board to overhang when it is attached to the Kelvin terminals (on the underside of the shunt). But doing that would cause the neutral bar to extend up into the ground bar assembly above it, so instead, I flipped the shunt 180 degrees.

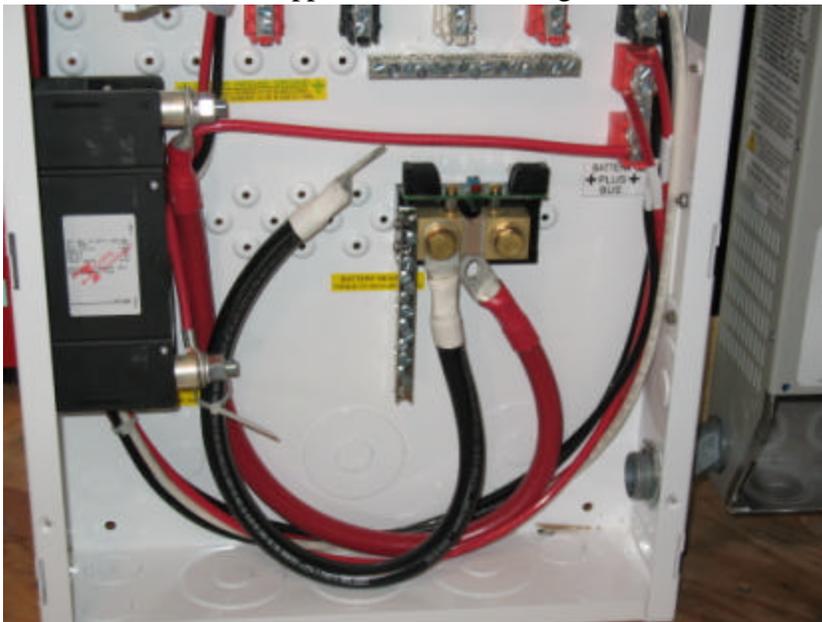
I also shifted the shunt to the right a couple of holes so that the neutral bar didn't get too close to the main DC breaker stabs. I could have mounted the neutral bar on the opposite end of the shunt but that would have meant drilling and tapping a couple extra holes and I'm basically a lazy guy.

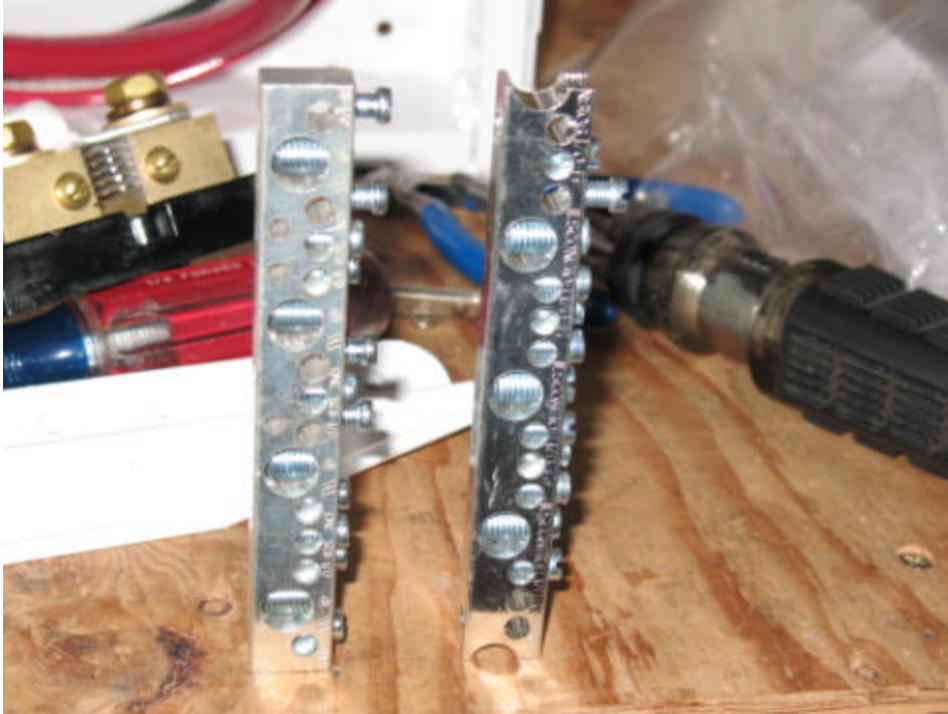
Midnite cuts their bus bars at different places than Outback does, so in Midnite's case the holes at the end of the busbar weren't the same spacing. Fortunately I had an extra Outback busbar, where the holes lined up, so I swapped it out. Remember what I just said about being a lazy guy?

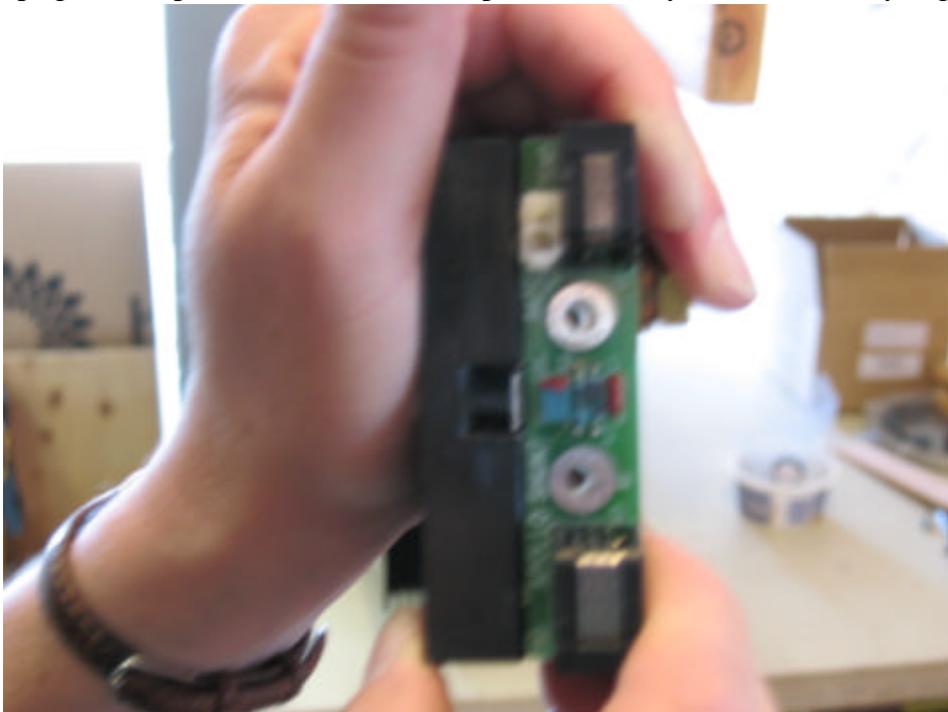
There's an item of note regarding the Apollo shunt board as well. When I went to mount the shunt board to the shunt, the holes didn't line up because the long edge of the shunt board butted up against the phenolic shunt base. The picture isn't very clear but I think you get the idea.

I don't think that this is a Midnite problem per se. I think it is an Apollo problem wherein they didn't leave enough clearance for variation amongst the different shunts that are procured by the power panel guys. I'm guessing that the specs on the locations of the Kelvin terminal drill holes aren't very tight, cause all the slop is accounted for in the final shunt calibration.

Anyway, I built up the standoff height with some extra brass washers I had lying around, and that took care of things, but I think Apollo might want to consider specifying a 7/16" standoff rather than a 5/16", 'cause us wrenches will end up doing some crazy things to deal with this.

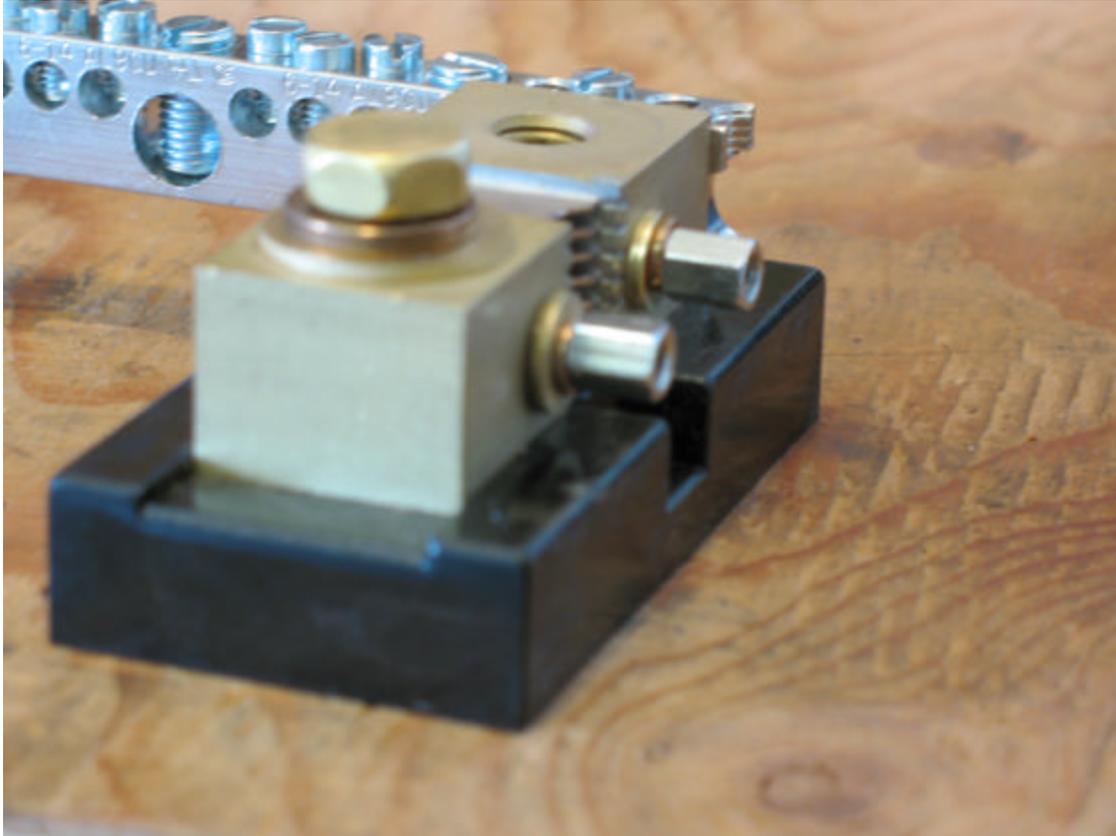
I was concerned about using non-brass washers, since there are already so many dissimilar metals in the millivolt signal path (is using an off-the-shelf mechanical standoff as a low-level signal carrying conductor a good idea to begin with)?
