## 165 VDC ETL TEST STORY

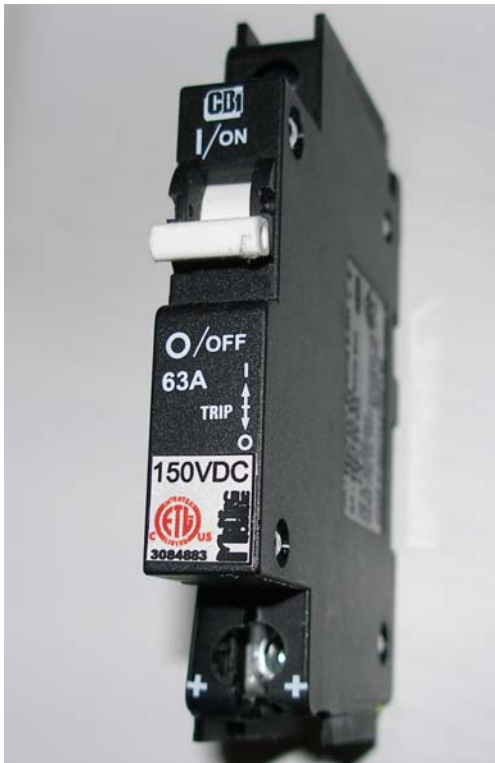
The breaker pictured is the MidNite MNEPV series breaker with the proposed ETL label installed. As of this writing, the label has not yet been submitted to ETL for approval, so production breakers may be labeled differently.

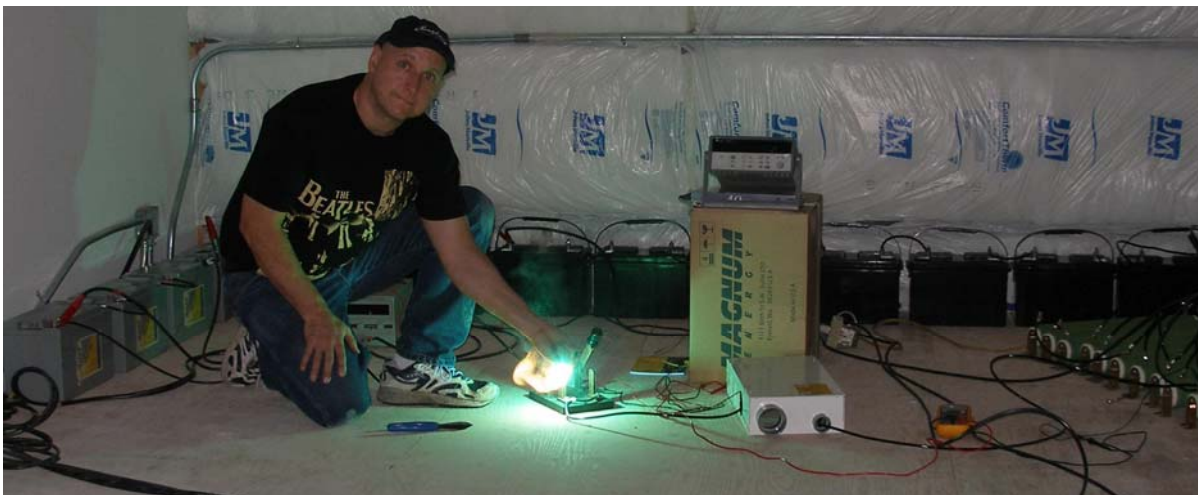
Pictured above, boB breaking 165VDC at 99 amps for the first test. This arc is the same arc that our little breaker must deal with internally. The arc is not only blinding, but also extremely hot. Pretty amazing huh! I also discovered the hard way that getting shocked with 165VDC feels pretty much the same as getting shocked with 120VAC.

The first test consisted of applying 165 volts of DC to the 63 amp breaker while running 99 amps of current through it. The test was done turning the breaker on for one second and then off for 9 seconds. This was done successfully 35 times. That was **16,335 watts** of high voltage DC the little breaker had to switch on and off. The first time we ran this prior to ETL being there, all we got was a melted down breaker fused solid in the closed position! It's a good thing we keep a hand on the knife switch for cases just like this. The breakers are marked with words stating "+ for DC". Now we better understand why this marking exists. We had it backwards and that doesn't allow the breakers internal arc shute to work effectively. Engineers rarely read directions before applying power to equipment. The + wording on the breaker was added by CBI on my recommendation years ago.
